Preliminary Assessment

Crawford Street Site Portland, Oregon

Prepared for Crawford Street Corporation

June 14, 2000

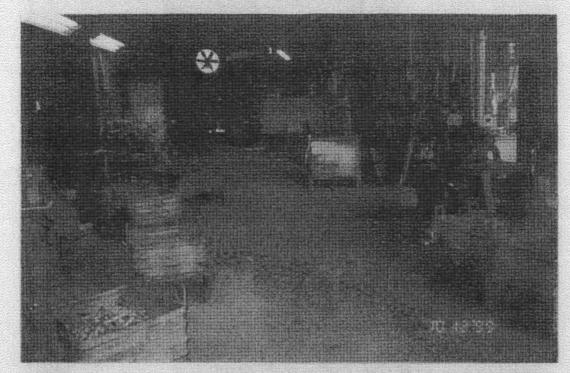
Photo No. 9

Southwest area of Columbia Forge Building 1. Looking south.

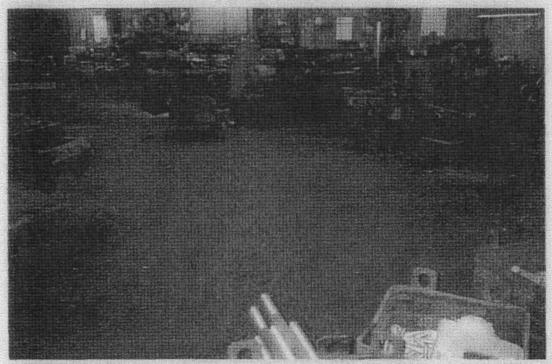
Photo No: 10

The northern portion of Building 1 is used for machining and contains several large lathes. This area has a sound concrete floor with no floor drains. Water-based cutting oils were observed in this area and the CSC representatives noted that the facility had been using water-based oil since the late 1970s. Prior to that time, petroleum-based cutting oils were used. No evidence of releases was observed in the machining room.

Machine Shop in north portion of Columbia Forge Building 1.

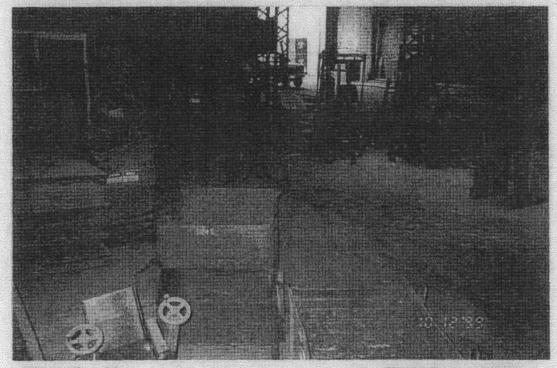
Photo No: 12

Inside Lampros Steel building at west end of site.

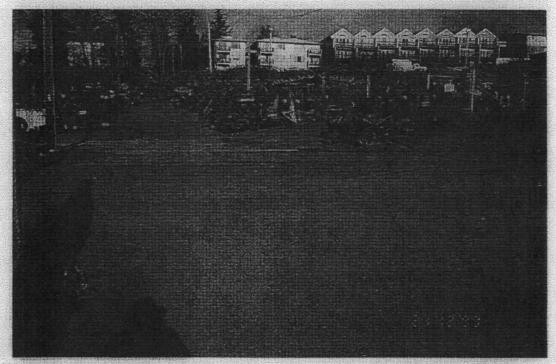
Photo No. 18

Storm water runoff from these up gradient areas flows on to, and across the CSC site. In particular, runoff flows off of the St. Johns Truck and Equipment site and flows on to the Lampros Steel property at the west end of the CSC site, onto the Columbia Forge yard, and onto the Columbia Forge and Lampros Steel yard at North John Street. A sheen was observed on this runoff during the site visit. CSC constructed an asphalt berm along the southern edge of North Crawford Street to reduce the amount of runoff coming on to the CSC site from up gradient properties.

Looking north from north side of Columbia Forge/Lampros Steel yard at St. Johns Truck and Equipment debris yard. Storm water runs from this area, across Crawford Street, and on to and across the storage yard.

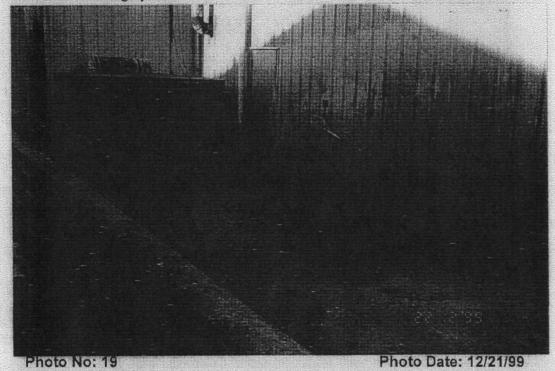
A heavily stained, uncovered wash pit is present immediately adjacent to North Crawford Street, across the street from the Columbia Forge office.

The approximate 15-foot by 30-foot area drains to a sump that presumably drains to the local storm water or sanitary sewer system. The concrete floor in the wash pit was heavily stained with petroleum hydrocarbons. What appeared to be a solvent cleaning tank was also located in the wash pit. Any releases from the solvent tank would also flow directly to the drain.

Stained wash area adjacent to Crawford Street at St. Johns Truck and Equipment. Across Crawford Street from Columbia Forge.

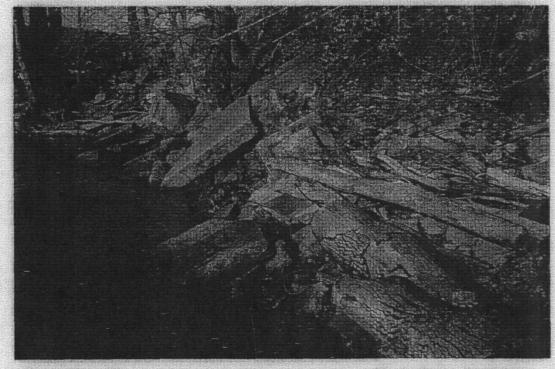
Photo No: 17

The riverbank is vegetated with blackberries and small trees. Most of the bank is covered with concrete debris and logs. Some of the concrete debris is larger than 6 feet with logs greater than 20 feet long. Smaller asphalt debris was also observed on the riverbank. Although the vegetation limited the ability to closely observe, no seeps were observed along the riverbank during the site reconnaissance. A nominal 8-inch diameter concrete pipe was observed protruding from the riverbank about 200 feet east of the western boundary of the CSC site. No evidence of recent flow from the pipe was observed (even after recent wet weather) and the pipe appeared to be associated with previous uses of the CSC site.

Typical river bank conditions.

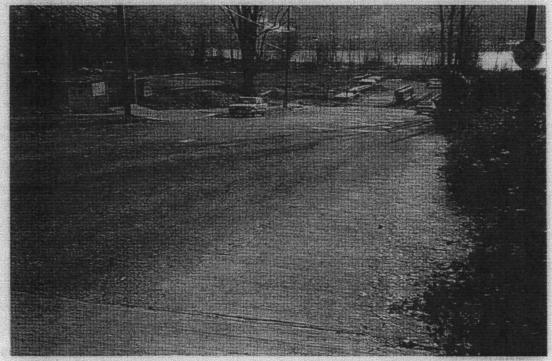
Photo No: 21

Looking south down North Richmond Street. Storm water flows down this street to UPRR rail spur area and to the Lampros Steel south storage yard.

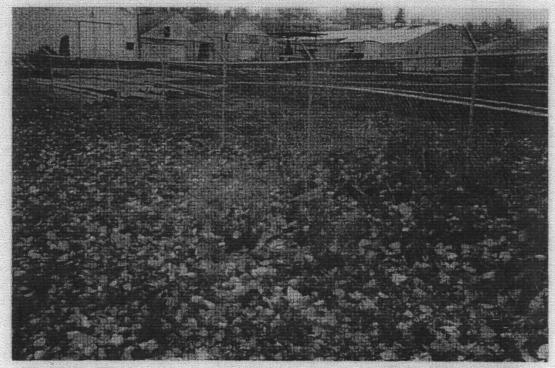
Photo No: 23

The property west (downriver) of the Southern Area of the CSC site is the location of the City of Portland Bureau of Environmental Services (BES) laboratory. This area is mostly paved with some landscaped areas. Storm water runoff in the eastern portion of this area is directed to a small ditch and wetland area in the eastern area of the BES property. A waste pile containing asphalt debris was observed on the eastern edge of the BES property, adjacent to the CSC property. The Willamette riverbank also contains concrete and asphalt debris at the eastern edge of the BES property.

Looking northeast from City of Portland property west of Crawford Street site. Note asphalt and concrete debris pile on City property.

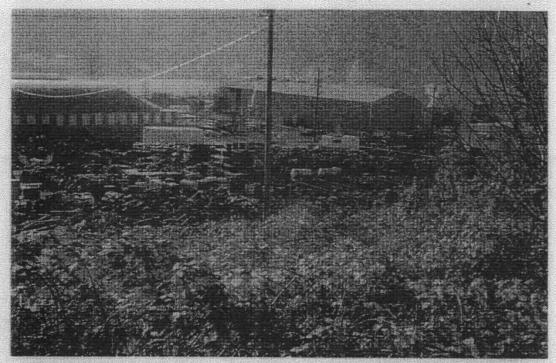
Photo No. 24

Looking south from hill above site. St. Johns Truck and Equipment debris yard north (up gradient) of Crawford Street site.

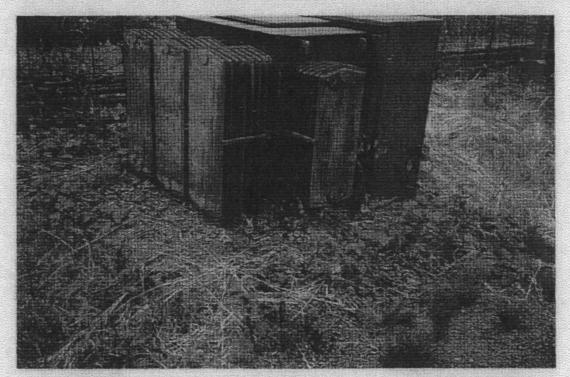
Photo No. 26

An electrical transformer is located on a 5-foot by 5-foot concrete pad in southwest portion of the Columbia Forge operations yard. There was no staining on the exterior of the transformer or the concrete pad or any other evidence of leakage from the transformer.

Transformer in southwest portion of Columbia Forge operations yard. Looking southwest.
